EX - HMAS SHEPPARTON

DISPOSAL/SAFE TO TOW INSPECTION REPORT

Report No: TS-C R 1549/01
Issue Date: 24th July 2023

G.A. Glanville & Co.
(Naval Architects) Pty Ltd
P.O. Box 642
CAIRNS QLD 4870

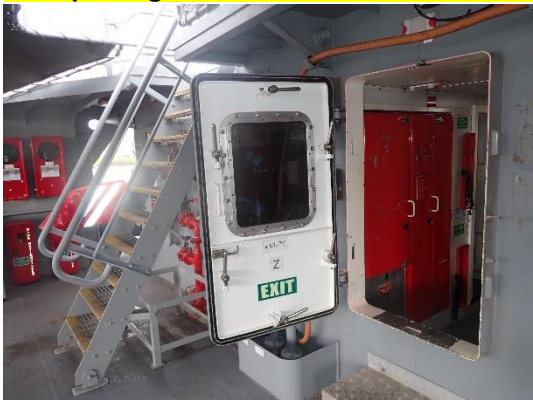
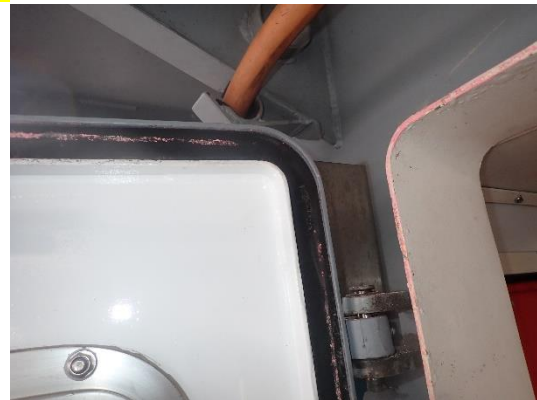
Main passage 1C-00 Aft WT door Fr.18 on C.L

- *Main passage 1C-00 Aft WT door Fr. 18 on C.L* – sealing rubber not contacting edge coaming IWO Port upper corner.
- *WT Door for AC compartment 1CZ4 Fr. 18* – sealing rubber not contacting edge coaming IWO locking tabs.
- *Port Engine Room Aft supply air vent flap* – Rubber seal not achieving contact due to misalignment to edge sealing surface on vent.
- *Stbd Engine Room supply air vent flaps* - Rubber seals not achieving 100% contact to edge of coaming.

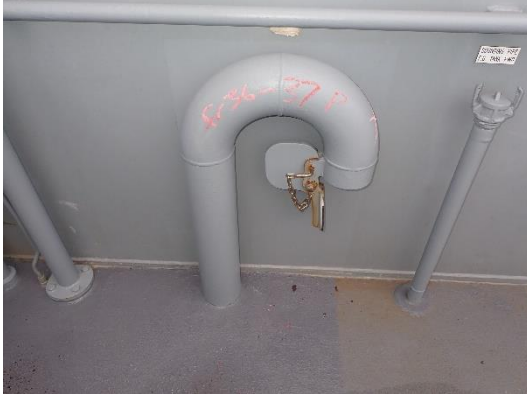
Goose neck vent pipe Port of C.L Fr.36 – Fr.37

- *Goose neck vent pipe Port of C.L Fr.36 – Fr.37 adjacent to house Bhd structure – Hinge/Bolting arrangement seized*
- *Goose neck vent pipe Stbd of C.L Fr.35 – Fr.36 adjacent to house Bhd structure – Hinge/Bolting arrangement seized*
- *Goose neck vent pipe Stbd of C.L Fr.48 – Fr.49 adjacent to house Bhd structure – Hinge/Bolting arrangement seized*

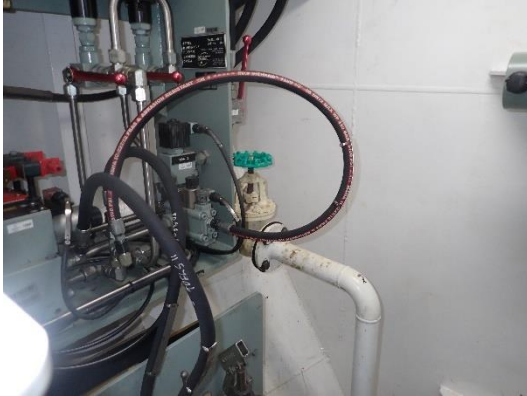
TDFLS sea tube vent valve Port of C.L

- *TDFLS sea tube vent valve Port of C.L* – Valve not lashed or fitted with isolation tag.
- *Overboard discharge valve loacted in Armoury Port of C.L* - Valve not lashed or fitted with isolation tag.
- *Port Engine Room Sea chest Vent Valve* - Valve not lashed or fitted with isolation tag.
- *Stbd Engine Room Sea chest Vent Valve* - Valve not lashed or fitted with isolation tag.

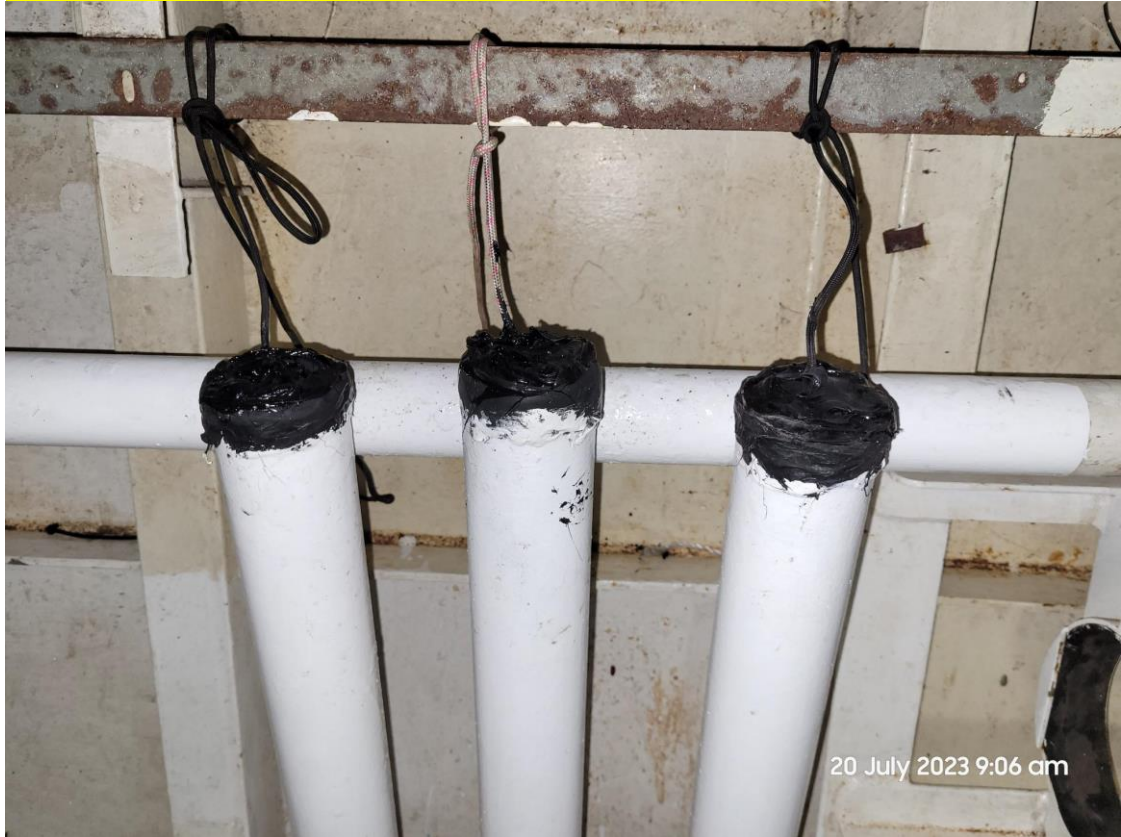
Sonar Cable Conduits Blanked & Sealed Stbd of C.L Fr.32 – Fr.33

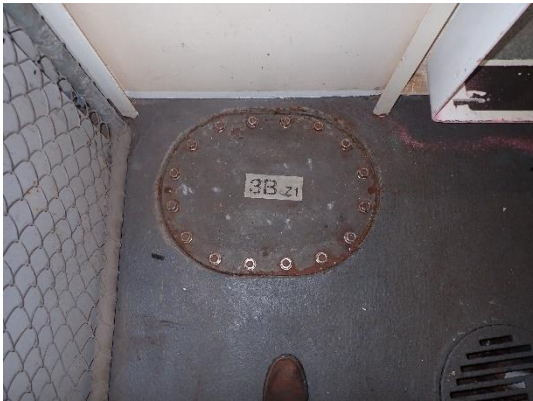
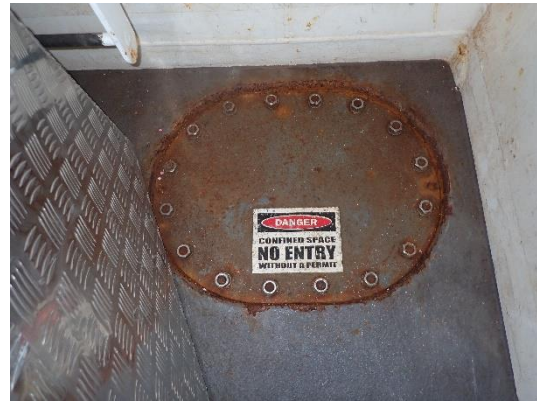
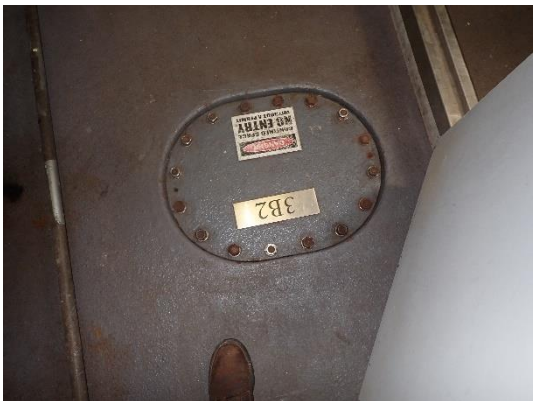
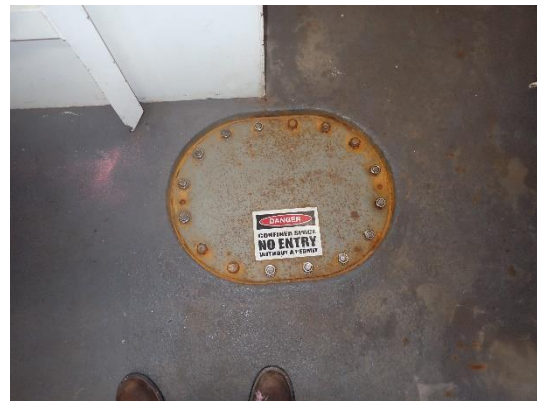
- 5.4 Tank lids were checked and confirmed that all fastenings were fitted. See below indicative photos of tank lids. See indicative photos below.

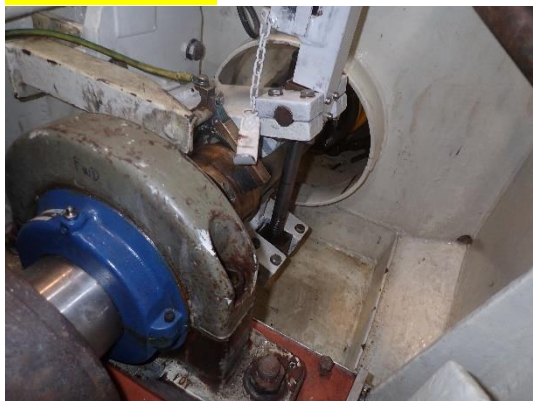
Port Side Shown

- 5.5 Firemain were opened, drained, and isolated following inspection. Isolation of firemain system was conducted at the main sea inlet intakes.
- 5.6 Propeller shafts brakes in Port and Stbd engine Rooms were confirmed to be in the locked position prevent rotation and Fwd and Aft movement. See indicative photographs below:

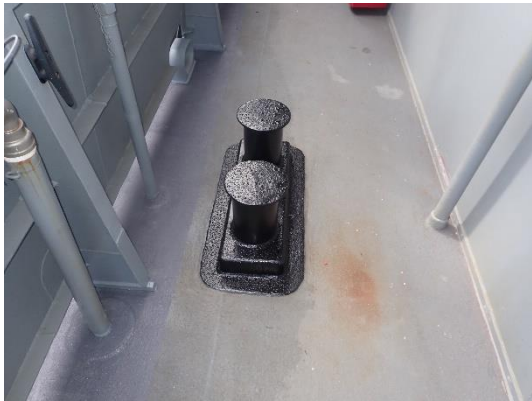
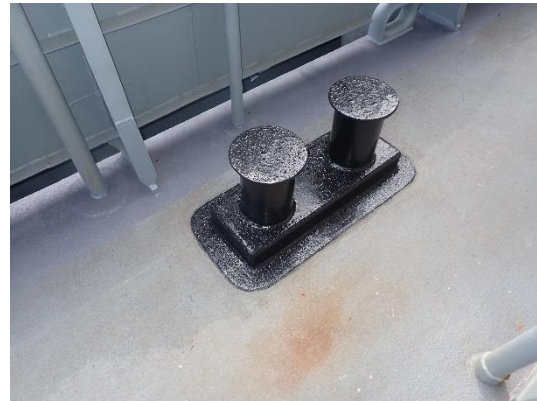
- 5.7 All bollards on the Forecastle, waists and Aft main deck were visually checked and intact. See indicative photographs below:
