EX - HMAS BENALLA

DISPOSAL/SAFE TO TOW INSPECTION REPORT

Report No: TS-C R 1549/02
Issue Date: 24th July 2023

G.A. Glanville & Co.
(Naval Architects) Pty Ltd
P.O. Box 642
CAIRNS QLD 4870

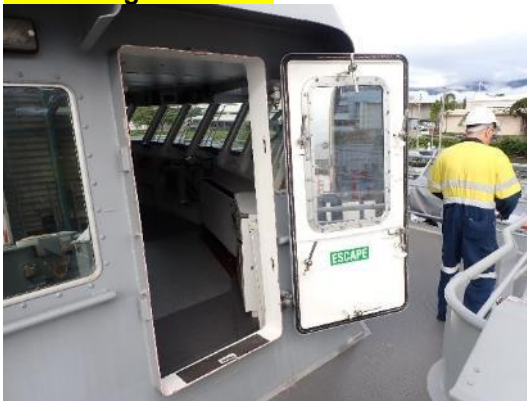
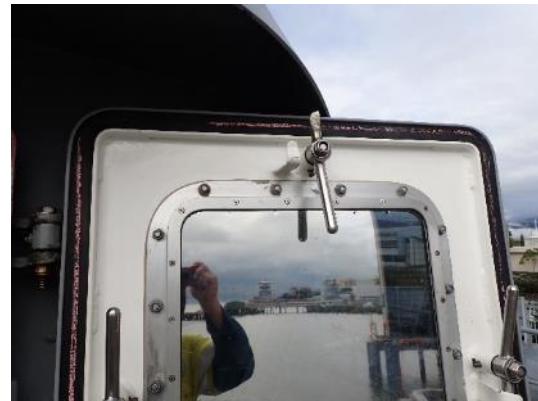
Stbd Bridge WT Door

- *Stbd Bridge WT Door* – Rubber seal not contacting knife edge coaming IWO upper FWD corner.
- *AC Compartment 1CZ4 WT Door* – Rubber seal not contacting knife edge coaming IWO inboard side.
- *Port Engine Room inboard Air intake* – Rubber seal misaligned IWO outboard knife edged sealing surface.
- *Stbd Engine Room exhaust air vent* – Rubber seal not achieving 100% contact IWO upper sealing surface.

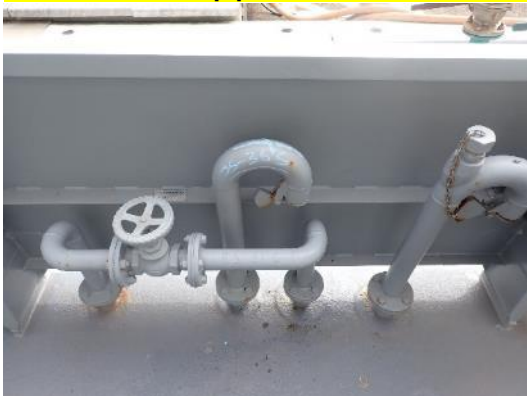
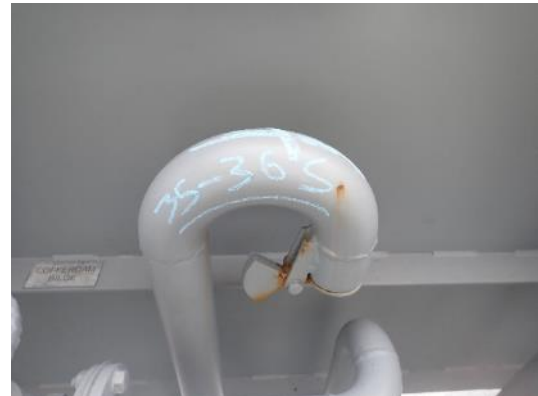
- Goose neck vent pipe Stbd of C.L Fr.35 – Fr.36 adjacent to Bulwark Structure – Hinge/Bolting arrangement seized.
- Goose neck vent pipe Stbd of C.L Fr.31 – Fr.32 adjacent to Bulwark Structure – Hinge/Bolting arrangement seized.
- Goose neck vent pipe Port of C.L Fr.47 – Fr.48 adjacent to Bulwark Structure – Hinge/Bolting arrangement seized.
- Goose neck vent pipe Port of C.L Fr.34 – Fr.35 adjacent to Bulwark Structure – Hinge/Bolting arrangement seized.

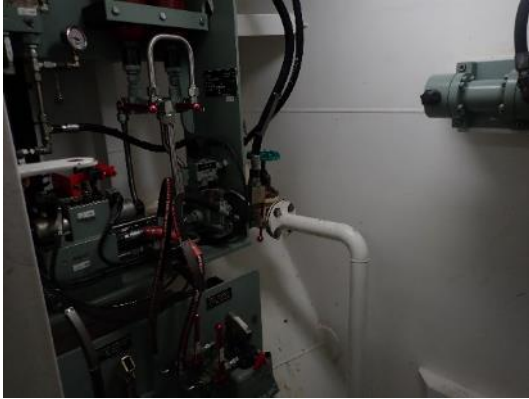
TDFLS Vent Line Valve

- *TDFLS Vent line overboard valve* – Not lashed and fitted with isolation tag.
- *Omnipure discharge overboard valve* – Valve unable to be physically isolated/lashed due do valve being of swing check valve type.
- *Sea chest Vent isolation valves* – Valve not lashed and fitted with isolation tag in both Port and Stbd Engine Rooms.
- *Grey Water OB discharge Valve Stbd of C.L located in Sick Bay (2CZ1)* - Valve unable to be physically isolated/lashed due do valve being of swing check valve type.
- *Grey Water OB discharge Valve Stbd of C.L in (2CA1)* - Valve unable to be physically isolated/lashed due do valve being of swing check valve type.

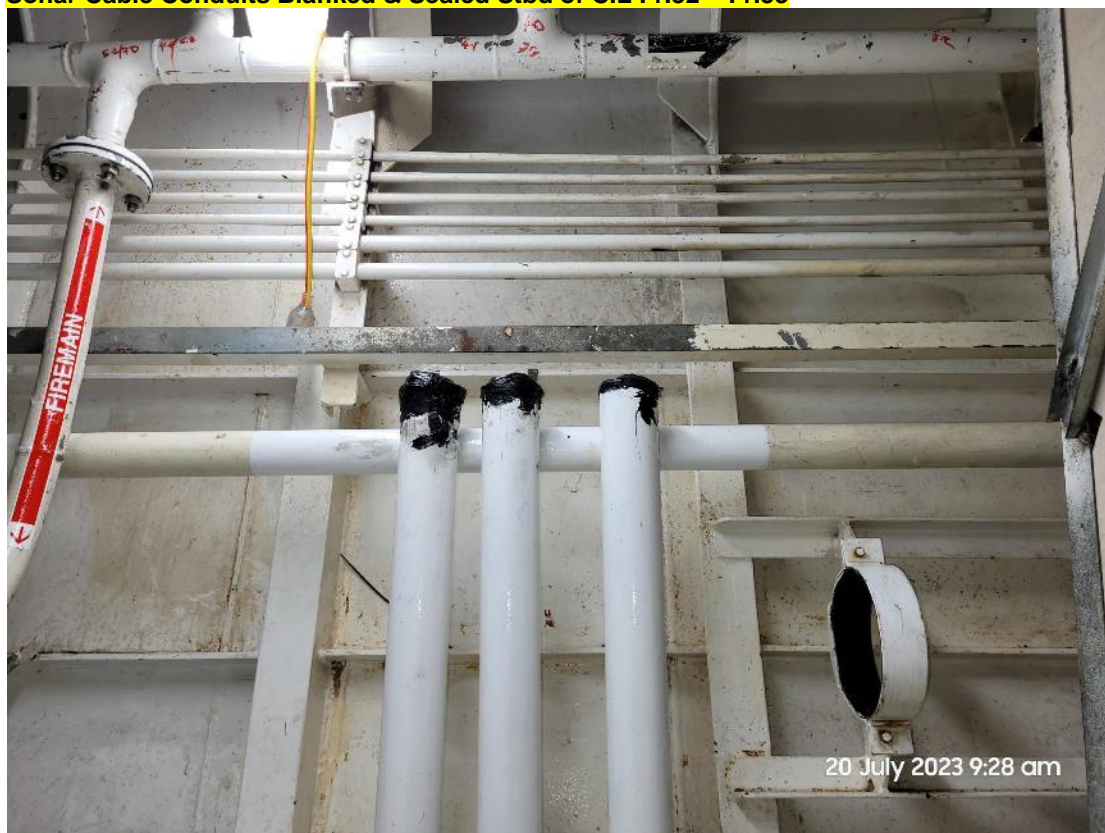
Sonar Cable Conduits Blanked & Sealed Stbd of C.L Fr.32 – Fr.33

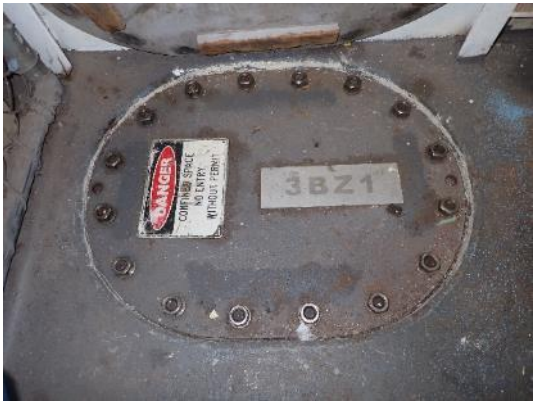
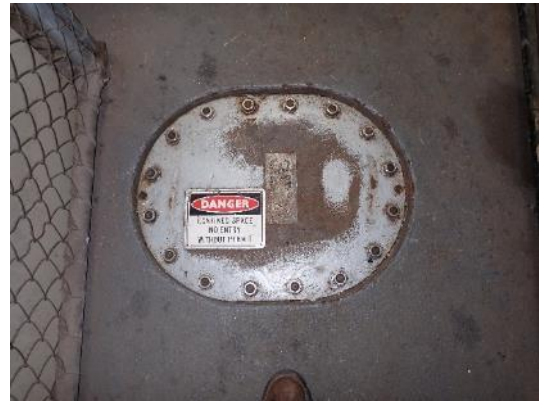
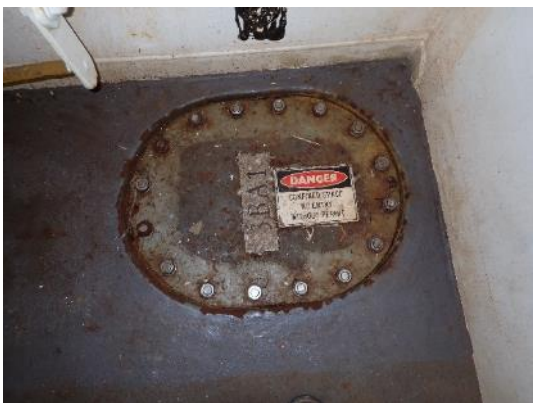
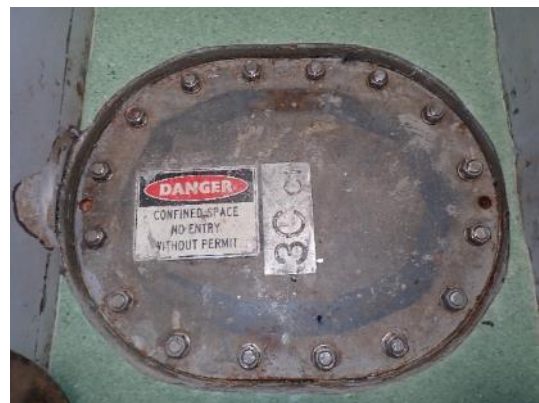
- 5.4 Tank lids were checked and confirmed that all fastenings were fitted. See below indicative photos of tank lids. See indicative photos below.

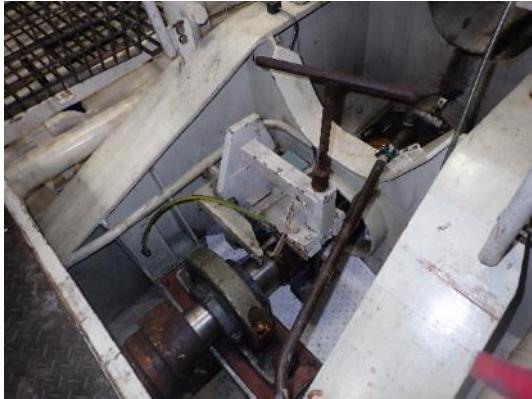
Port Side Shown

- 5.7 Propeller shafts brakes in Port and Stbd engine Rooms were confirmed to be in the locked position preventing rotation and Fwd and Aft movement. See indicative photographs below:

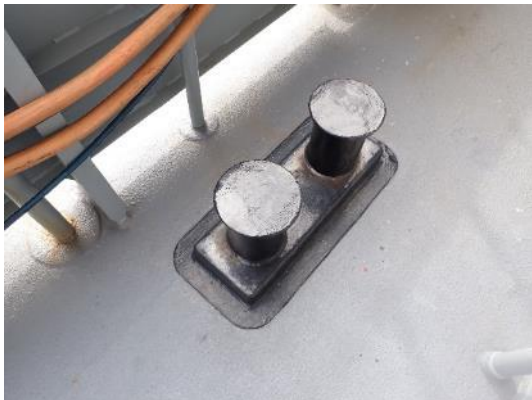
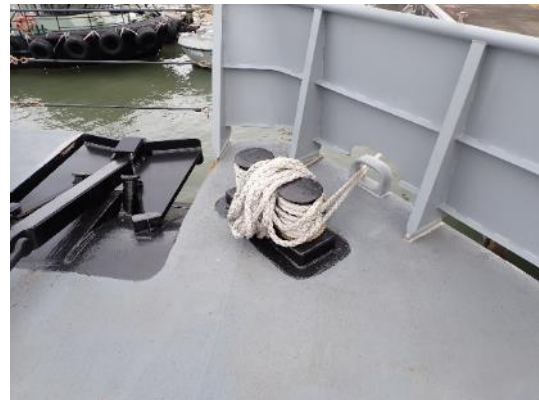
- 5.8 All bollards on the Forecastle, waists and Aft main deck were visually checked and intact. See indicative photographs below:

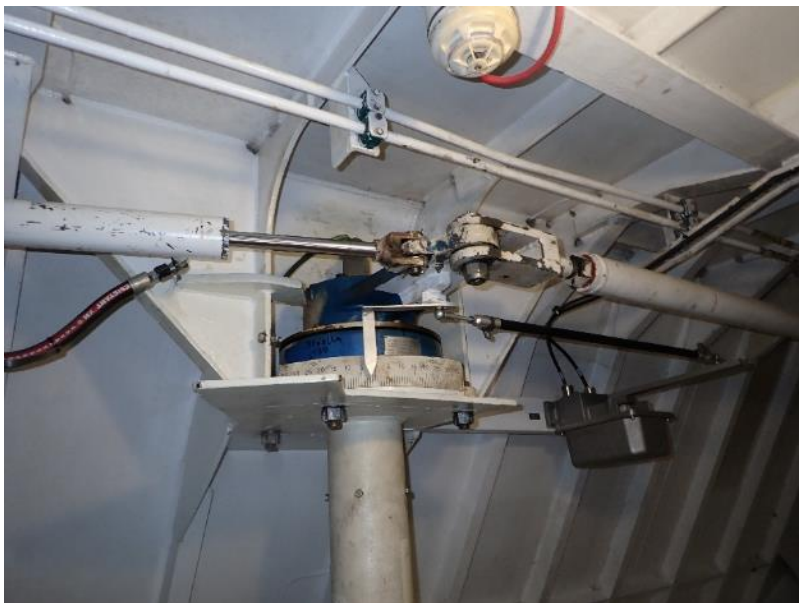
- 5.9 Rudder securings were inspected as part of Benalla's Safe to Tow checklist *section 3.g* and were witnessed to be secured by ships original mechanical configuration. See indicative photograph below.
